OPERATING EXPERIENCE WEEKLY SUMMARY

Office of Nuclear and Facility Safety

September 18 - September 24, 1998

Summary 98-38

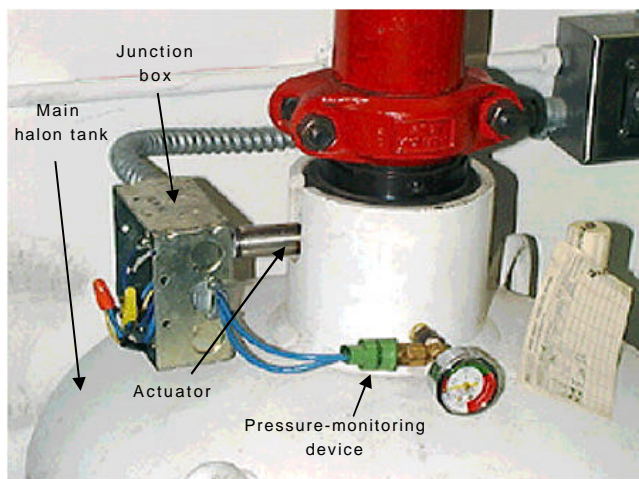
Figure 3-1. Halon System Junction Box

On September 11, 1998, at the Hanford Site Plutonium Finishing Plant, Hanford Fire Department personnel were performing a halon system functional test when the halon system discharged. All personnel immediately evacuated the building, and no one was injured. Investigators determined that the discharge was the direct result of electricians disconnecting wires from a halon tank pressure monitoring device instead of a halon discharge actuator. They also determined that personnel performed the work using a generic work package for preventive maintenance of site fire protection systems. Mis-identifying actuator wires while conducting operability checks resulted in inadvertent actuation of a fire suppression system. (ORPS Report RL--PHMC-PFP-1998-0040)

Investigators determined that Hanford Fire Department personnel deactivated the fire alarm panel, warned personnel in the building of the work that was to be performed, and described actions personnel should take if the halon system accidentally discharged. They then placed the "armed/disarmed" switch in the disarmed position. Electricians opened a junction box and disconnected what they thought were the actuator wires. The Hanford Fire Department captain activated the manual pull station, and the electricians observed no response at the actuator. Hanford Fire Department personnel reset the pull station and placed the "armed/disarmed" switch in the armed position. When personnel activated the pull station, the halon system discharged. Investigators determined that the work package did not provide details for deactivating the halon system and did not include a wiring diagram. Figure 3-1 shows the junction box, actuator, and pressure monitor. The halon system will remain on a reserve tank until personnel refill the main tank.

These events underscore the importance of having detailed procedures and drawings, even when the task seems simple and straightforward. Planners must use the best available drawings and should consider conducting detailed walk-downs to ensure wires are correctly identified. These events also underscore the importance of technicians maintaining questioning attitudes and paying attention to detail to ensure that operability tests are performed safely. If electricians had correctly identified the actuator wires in the junction box, this event could have been prevented. Technicians should be trained in the importance of questioning attitudes and attention to detail. They also must be trained in how to correctly perform independent verifications.
